**Supplemental Engineering Report for Case No.  
21CW3008(B)  
AngelView, LLC, Application for Storage, and  
Plan for Augmentation including Exchange  
Issues Dealing with the Course of the Natural Stream  
known as Bartlett Gulch**

**Martin and Wood  
Water Consultants, Inc.**

May 27, 2022

Project No. 904.2

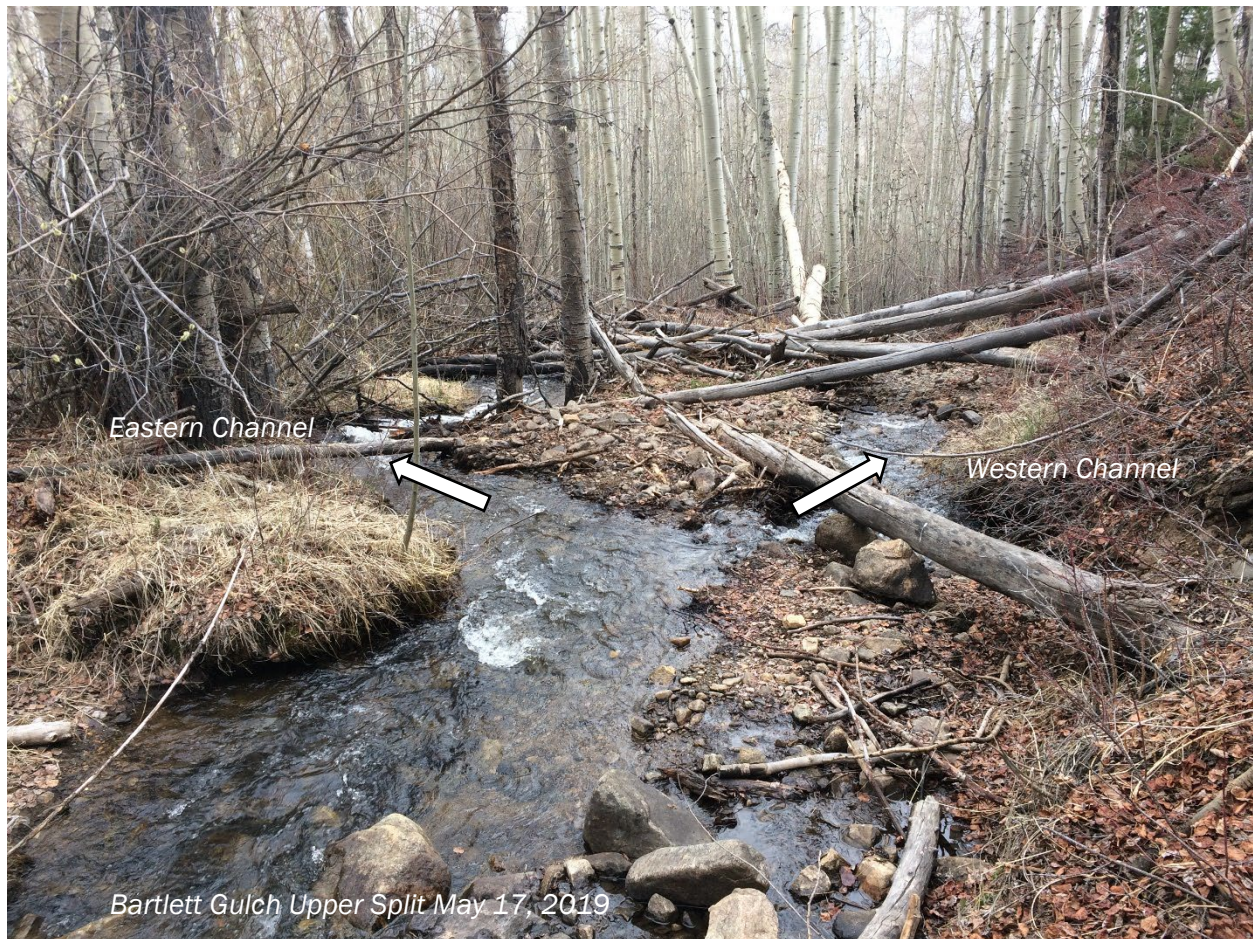
The above photograph shows the Upper Split of Bartlett Gulch prior to the installation of the Engineer's Upper Dam. Note that the majority of the flow is in the Eastern Channel and that the Western Channel is obstructed by a berm, fluvial deposits, a fallen tree, and a few large rocks.

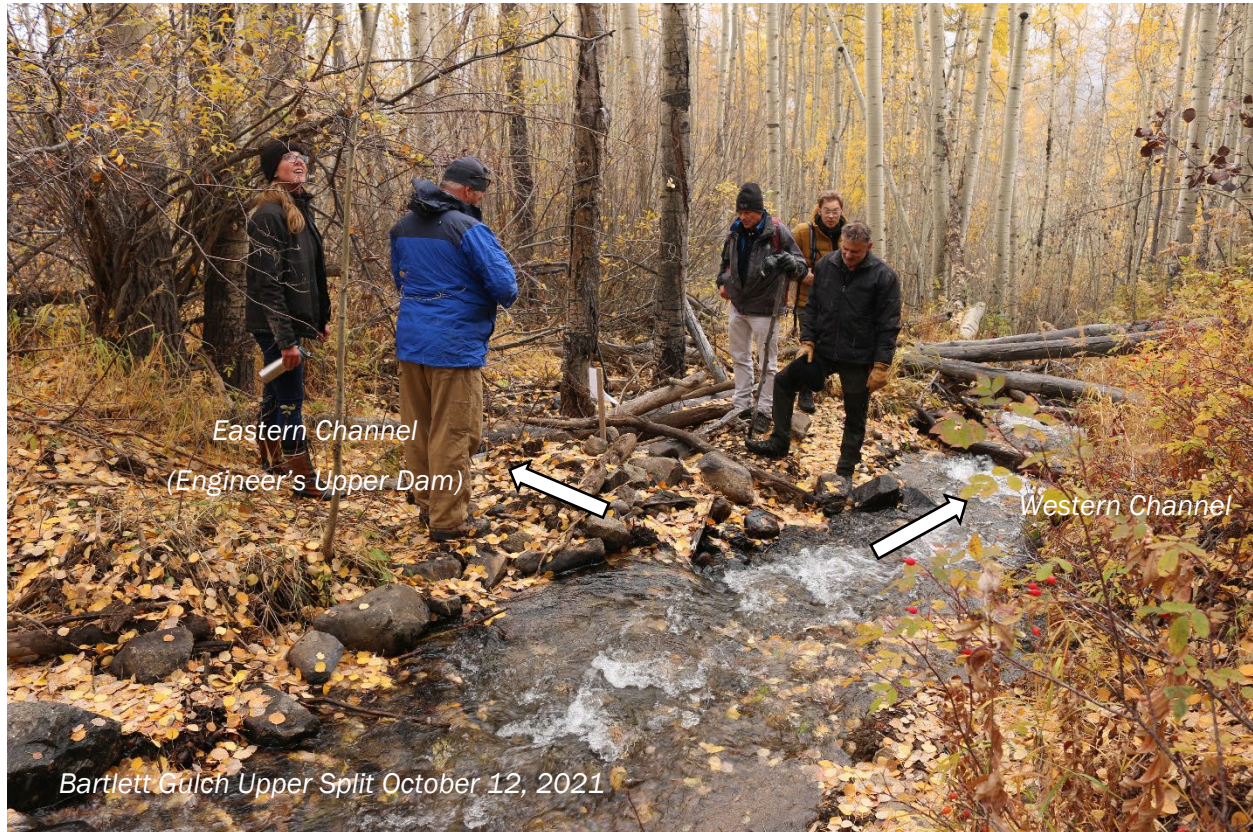
The above photograph shows the Upper Split of Bartlett Gulch after installation of the Engineer's Upper Dam. Note that the berm, fluvial deposits, fallen tree, and rocks that were previously present in the Western Channel have been removed, and that the rocks appear to have been placed along the eastern bank and now form a protective barrier hindering erosion of the eastern bank and flow to the Eastern Channel. The Western Channel appears to have been widened when compared to the pre-dam installation conditions.

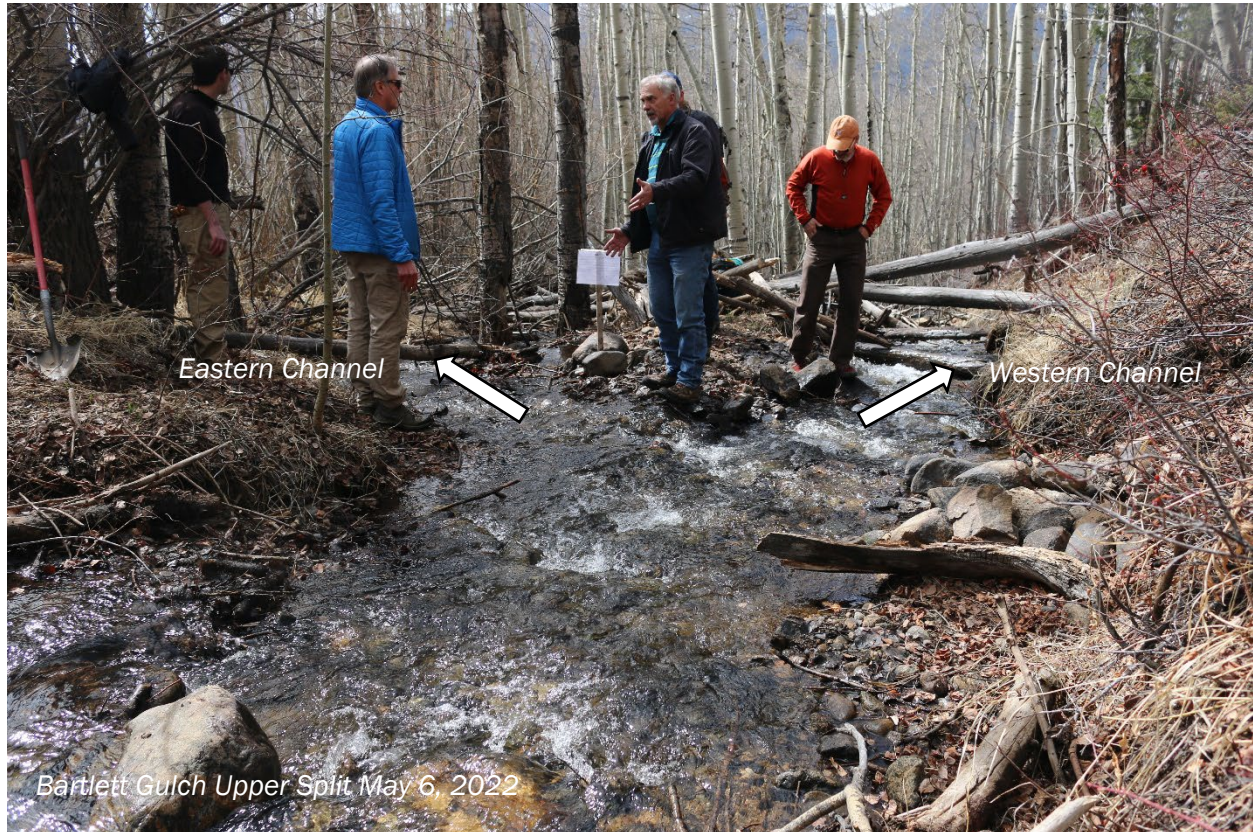
The above photograph shows the Upper Split of Bartlett Gulch after removal of the Engineer's Upper Dam. Note that neither the berm and rocks that were in the Western Channel prior to the installation of the dam, nor the tree over the opening to the Western Channel were reinstalled, though the rocks placed along the eastern bank were removed. The majority of the streamflow is now in the Western Channel rather than the Eastern Channel, which is opposite to the pre-dam installation conditions. The Western Channel remains widened when compared to the pre-dam installation conditions. An excellent visualization of the post dam removal flow is also shown in the video MVI\_8402.

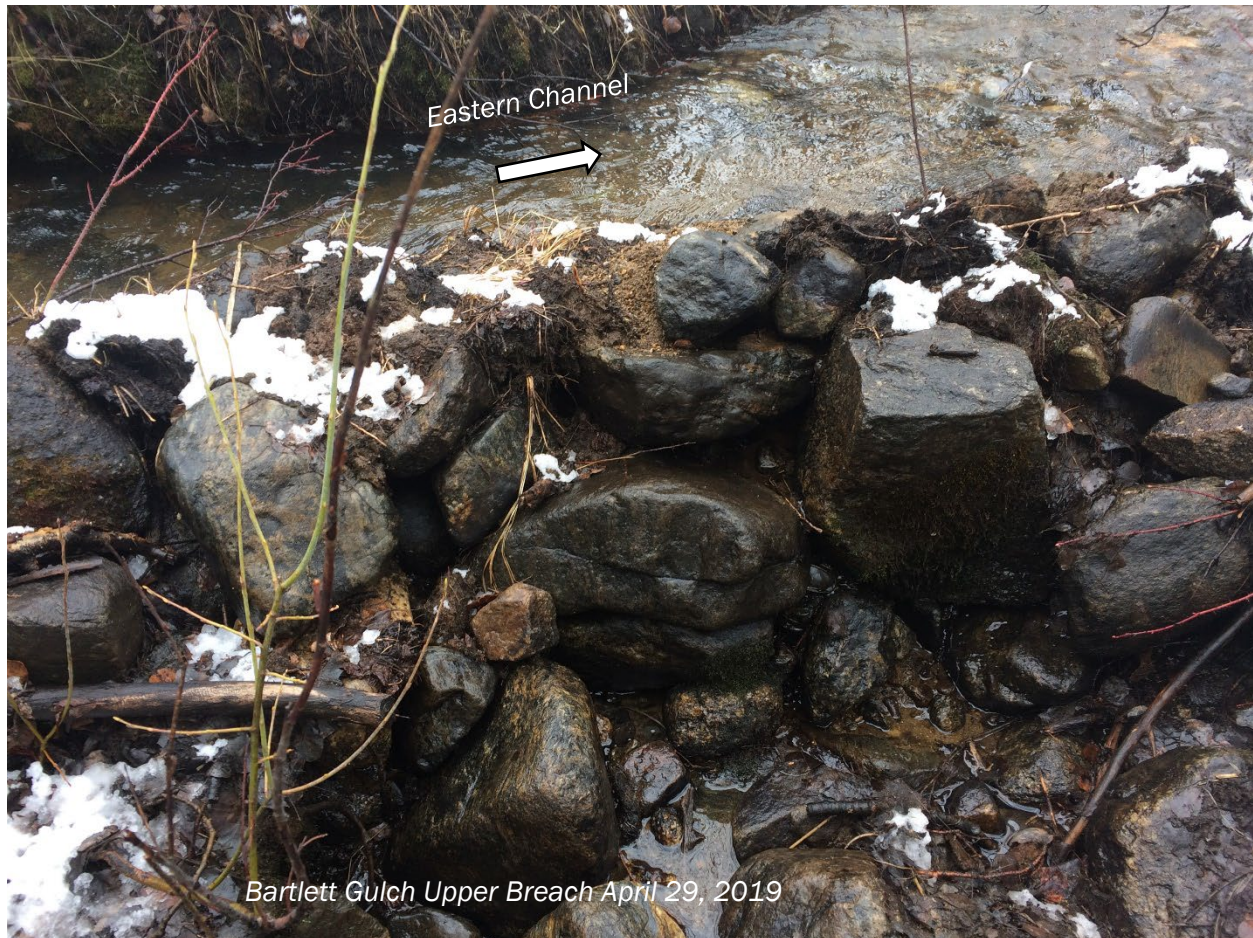
The above photograph shows the Upper Breach on the Eastern Branch of Bartlett Gulch prior to the installation of the Engineer's Lower Dam. The Upper Breach is approximately 80 feet downstream of the Upper Split of Bartlett Gulch. It is useful to use the branch visible on the left side of the photograph as a reference point in the following photographs.

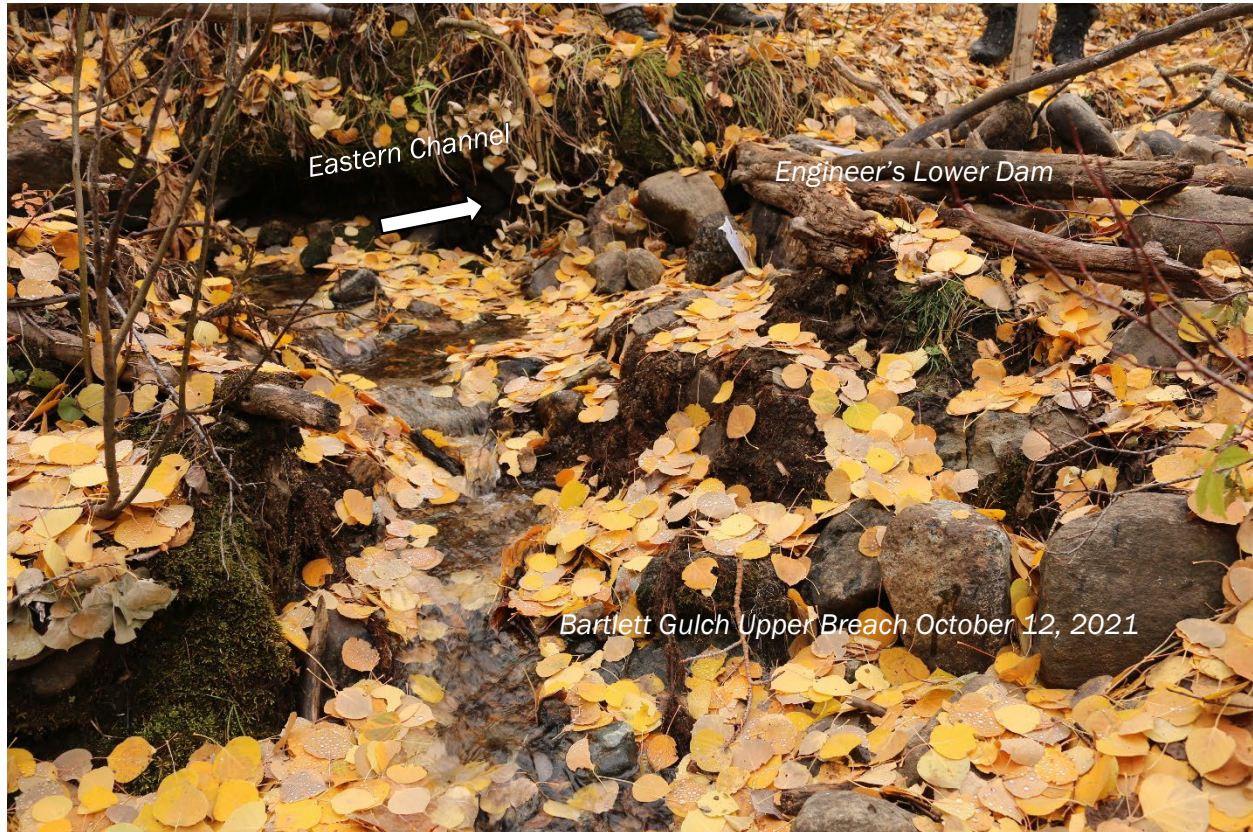
The above photograph shows the previous location of the Upper Breach on the Eastern Branch of Bartlett Gulch after installation of the Engineer's Lower Dam. The Upper Breach has been removed to redirect any flow that was in the Eastern Channel to the Western Channel. This flow may include flow leaking through the Engineer's Upper Dam as well as subsurface flow. Using the branch visible on the left side of the previous photograph, make note of the level of the bottom of the channel that was created through the removal of the Upper Breach.

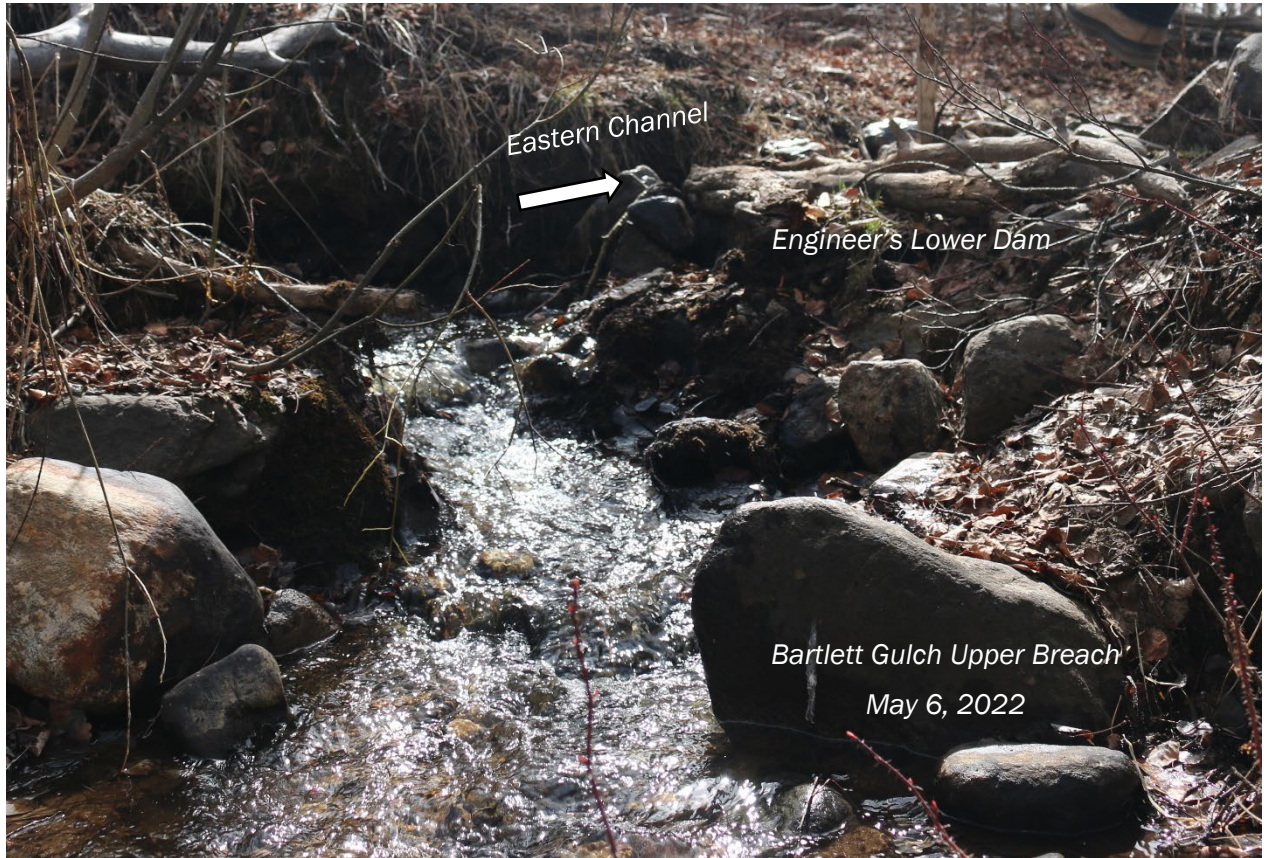
The above photograph shows the previous location of the Upper Breach on the Eastern Branch of Bartlett Gulch just prior to removal of the Engineer's Lower Dam. It appears that the stream channel has eroded to some extent (visible behind and below the branch), lowering the level of the return from the Eastern Channel to the Western Channel.

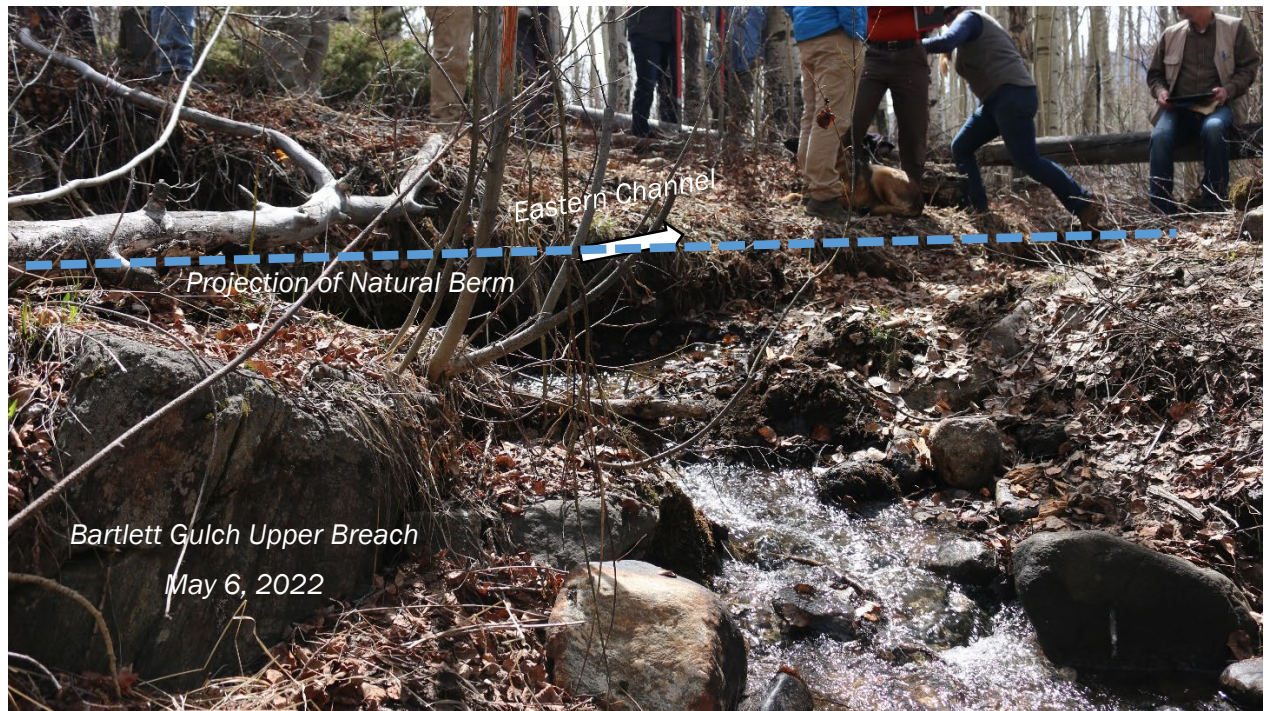
The above photograph shows the previous location of the Upper Breach on the Eastern Branch of Bartlett Gulch after removal of the Engineer's Lower Dam. Note that no flow is in the Eastern Channel, and that the base of the Eastern Channel is too high to accommodate any flow where the channel makes an approximately ninety degree turn towards the Western Channel. It is our opinion that an approximately ninety degree turn through a berm is not something a natural stream channel would do. The dashed blue line represents a breach in the western berm of the Eastern Channel, which based on the elevation of the top of the berm and the presence of what appears to be natural boulders and mature vegetation appears to have been breached by humans and is described further below. Again note that the breach is essentially at a right angle (approximately ninety degrees) to the flow direction in the Eastern Channel.

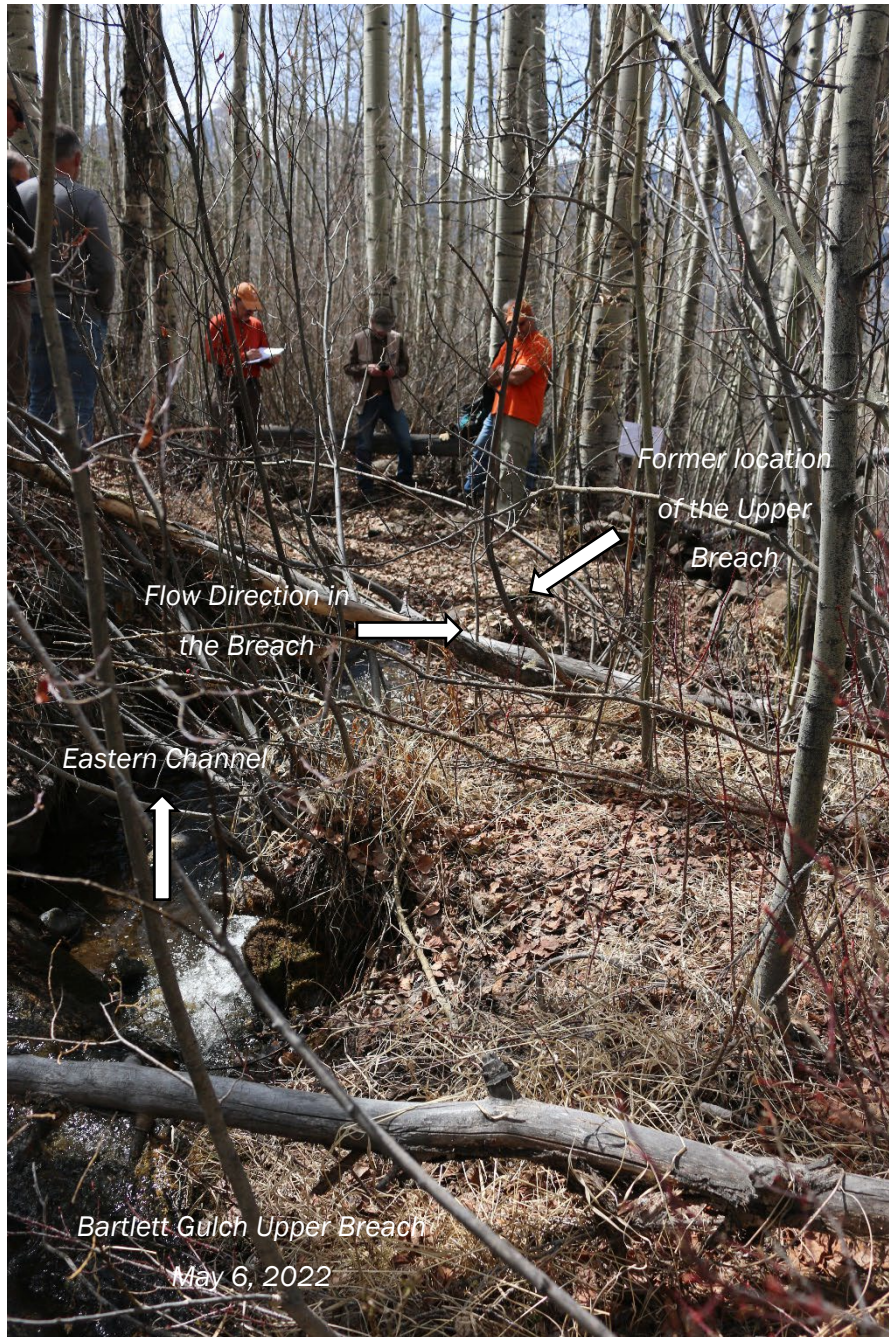
The adjacent photograph illustrates what appears to be a continuous natural berm on the west side of the Eastern Channel. The former location of the Upper Breach represents a breach in the berm. This is the location of the dashed blue line in the previous photograph.

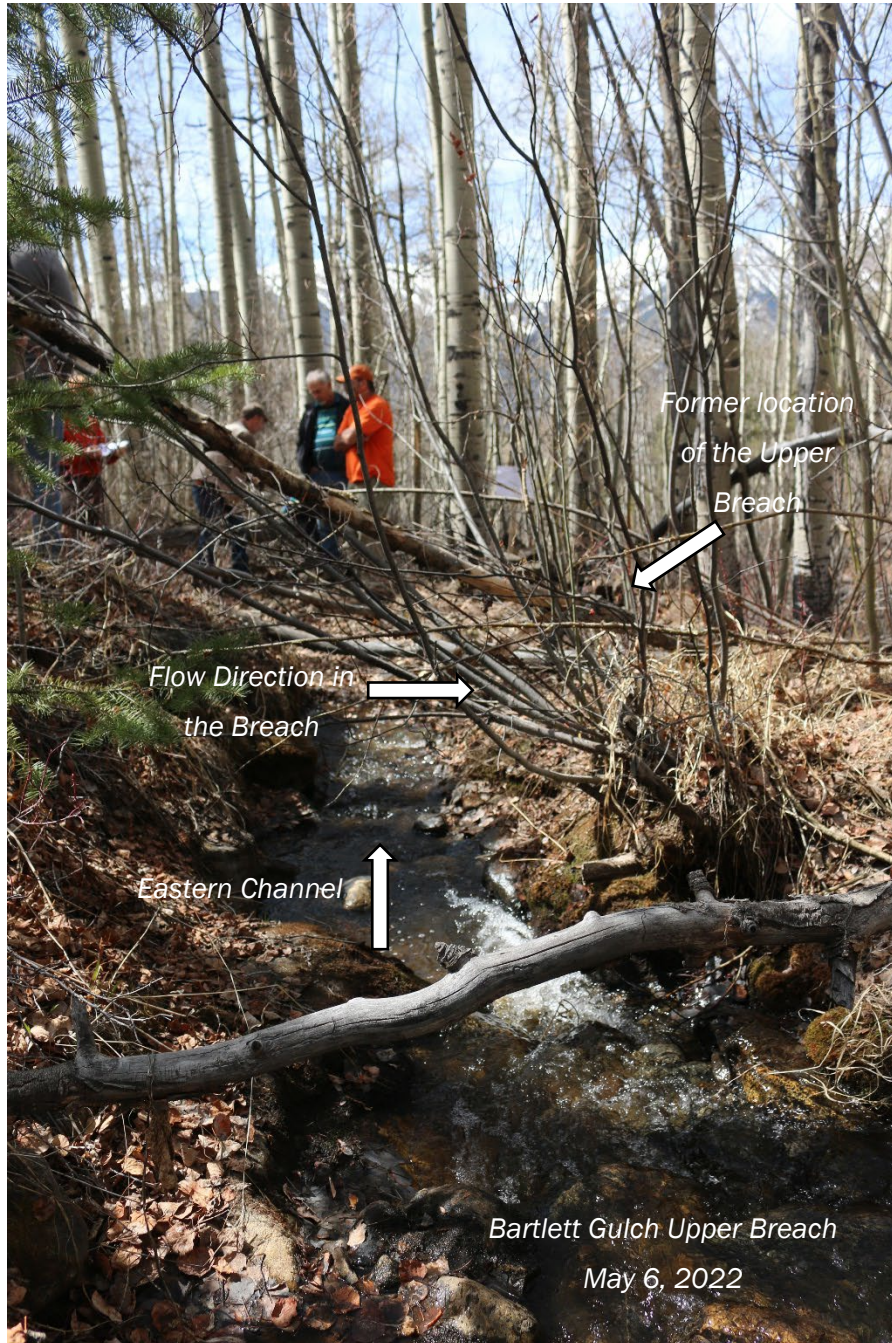
The adjacent photograph also illustrates what appears to be a continuous natural berm on the west side of the Eastern Channel before the location of the Engineer's Lower Dam and breached berm. The former location of the Upper Breach represents a breach in the berm. This is the location of the dashed blue line in the previous photograph.

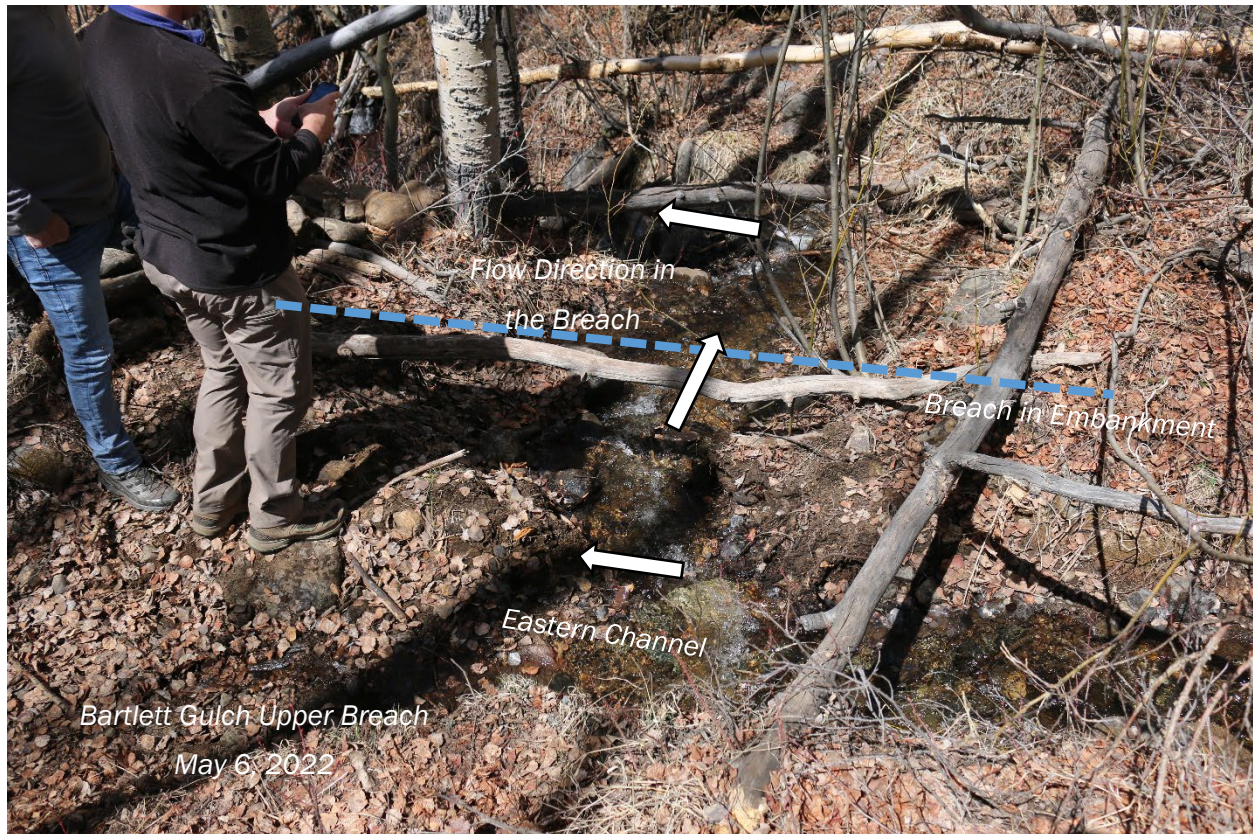
The above photograph illustrates the flow in the breach of the berm on the western bank of the Eastern Channel (the log spanning the breach, underneath the dashed blue line, was placed to represent the potential previous extent of a continuous berm). Note that the flow direction is essentially perpendicular to the Eastern Channel and takes another right-angle (approximately ninety degree) turn shortly after existing the channel to follow the slope of the terrain. It is our opinion that right angle or approximately ninety degree turns in a stream channel are not natural. The break in the berm may be manmade, as were the repairs in the berm consisting of the Upper Breach illustrated in the April 29, 2019 photograph earlier in this section. An excellent visualization of the berm/breach is also shown in the videos MVI\_8411, MVI\_8414, MVI\_8421, and 67512668287\_\_570EBEA5-DF60-43CF-A549-CB0950AD25B6.MOV

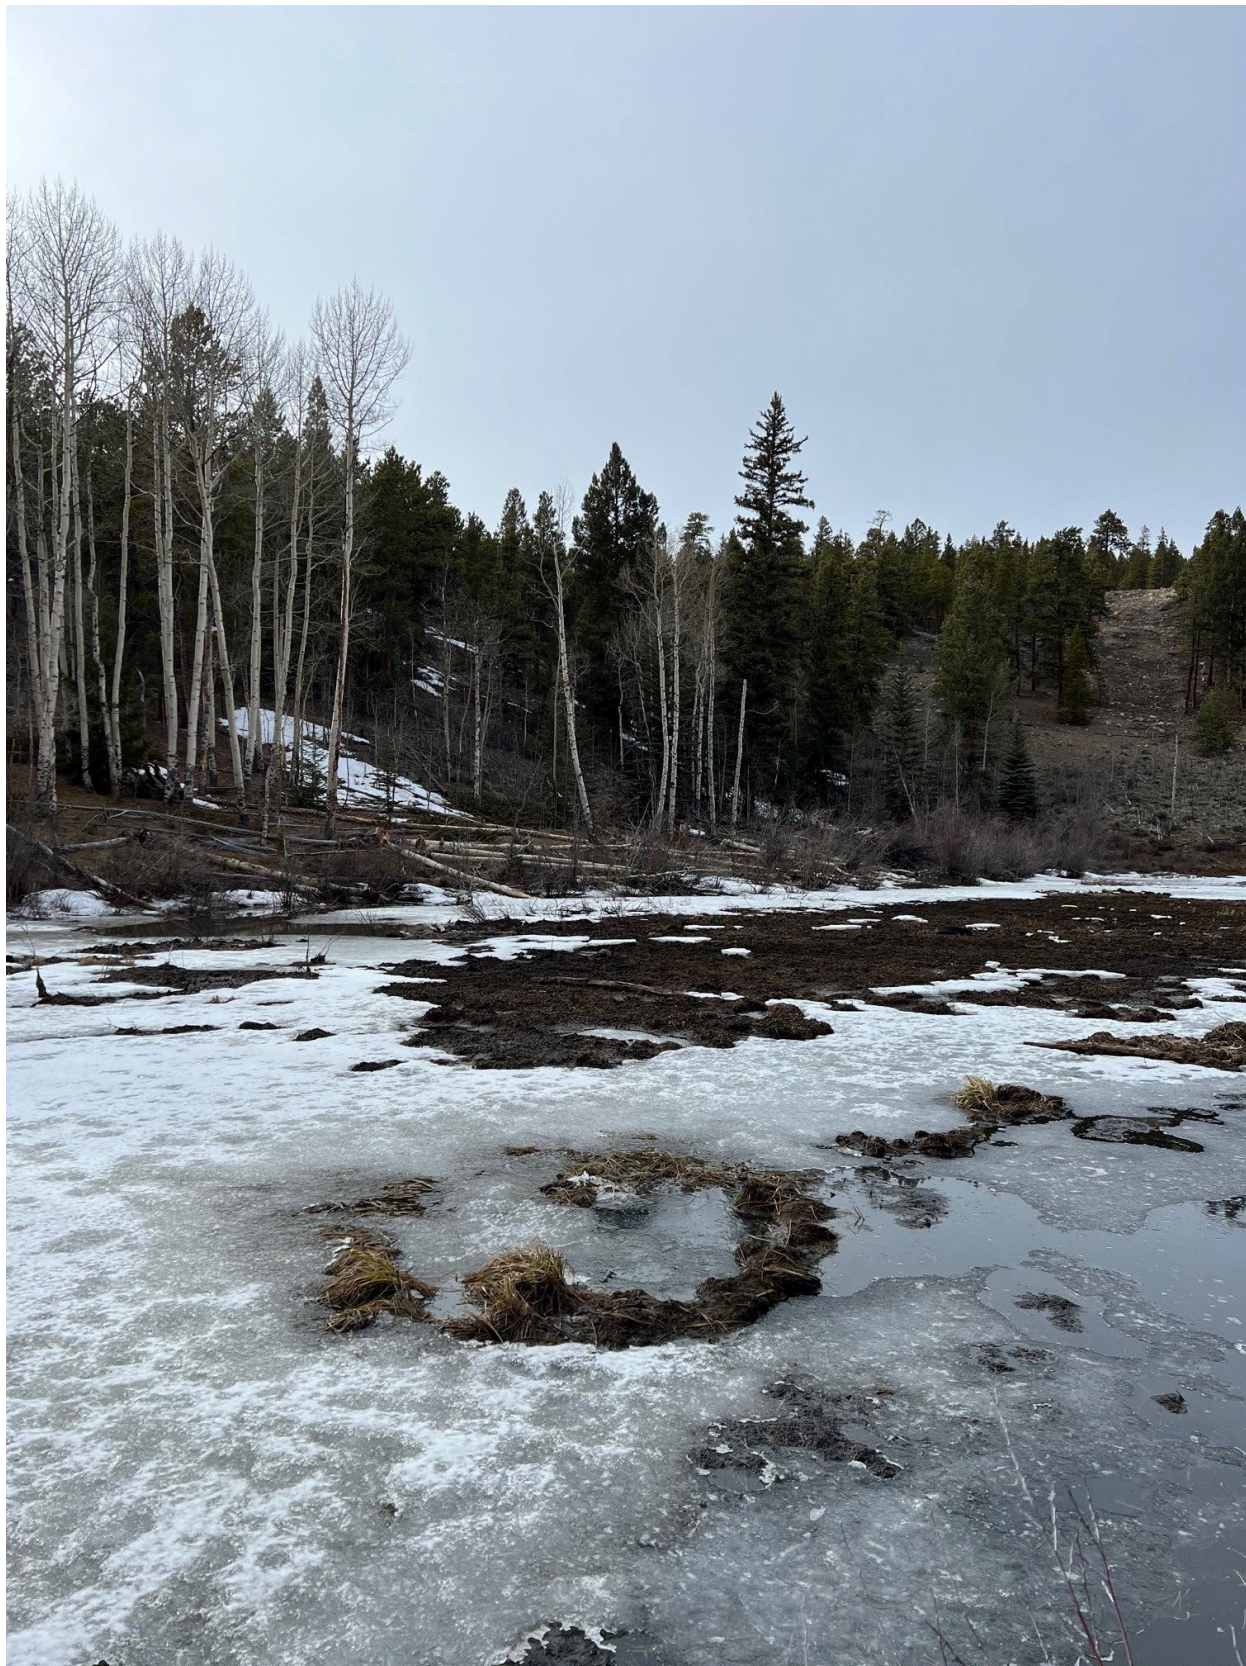
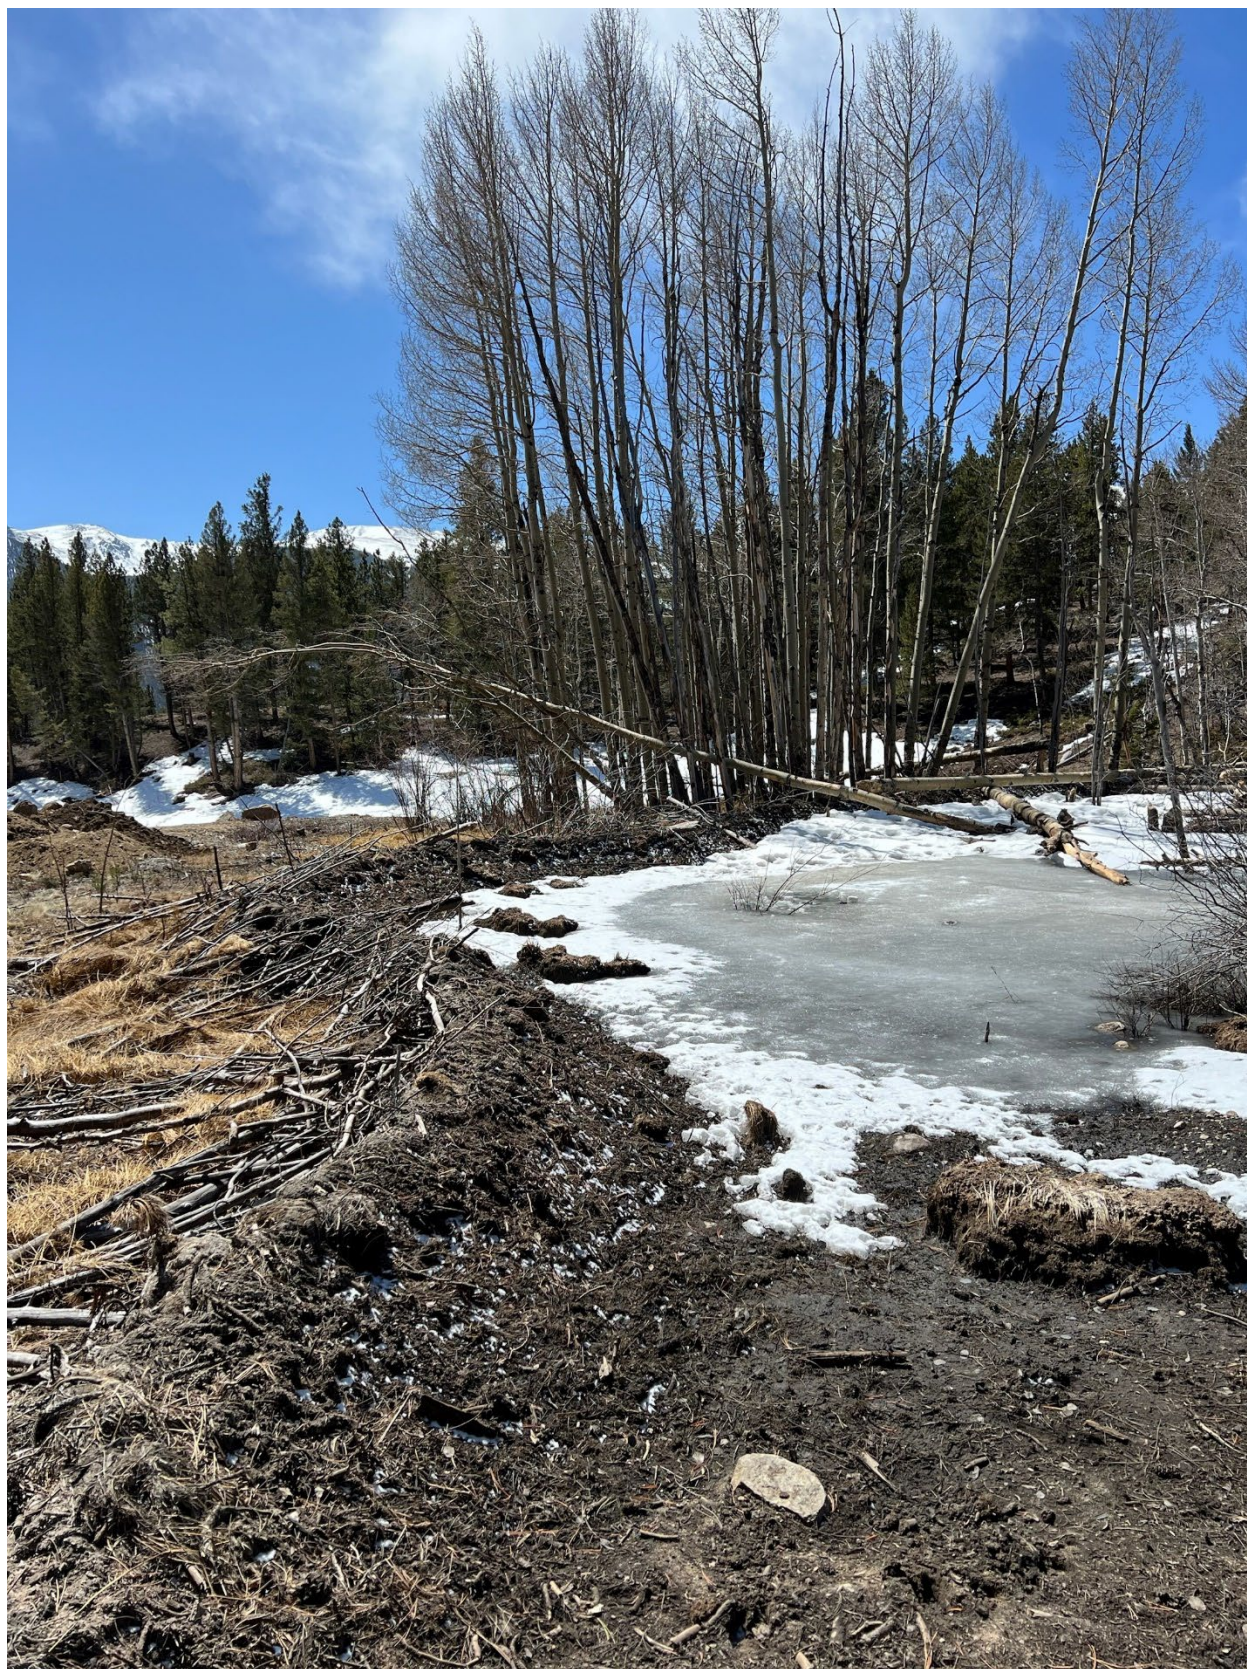
Per Alan Elias, the AngelView Manager, the surface water flow from Bartlett Gulch to the Eastern Channel was temporarily terminated through the construction of a temporary dam by the Colorado Department of Water Resources Division 2 personnel (DWR) on or about September 22, 2021. At the time that the Eastern Channel surface water flow was temporarily terminated, Fen A on the AngelView property (Figure 2.7 from our March 7, 2022 disclosure) was fully saturated and had standing water. On April 10, 2022, Alan Elias sent to Martin and Wood the two photographs included below showing the drying up of Fen A, with the water level decline in Fen A estimated at approximately 3 feet.

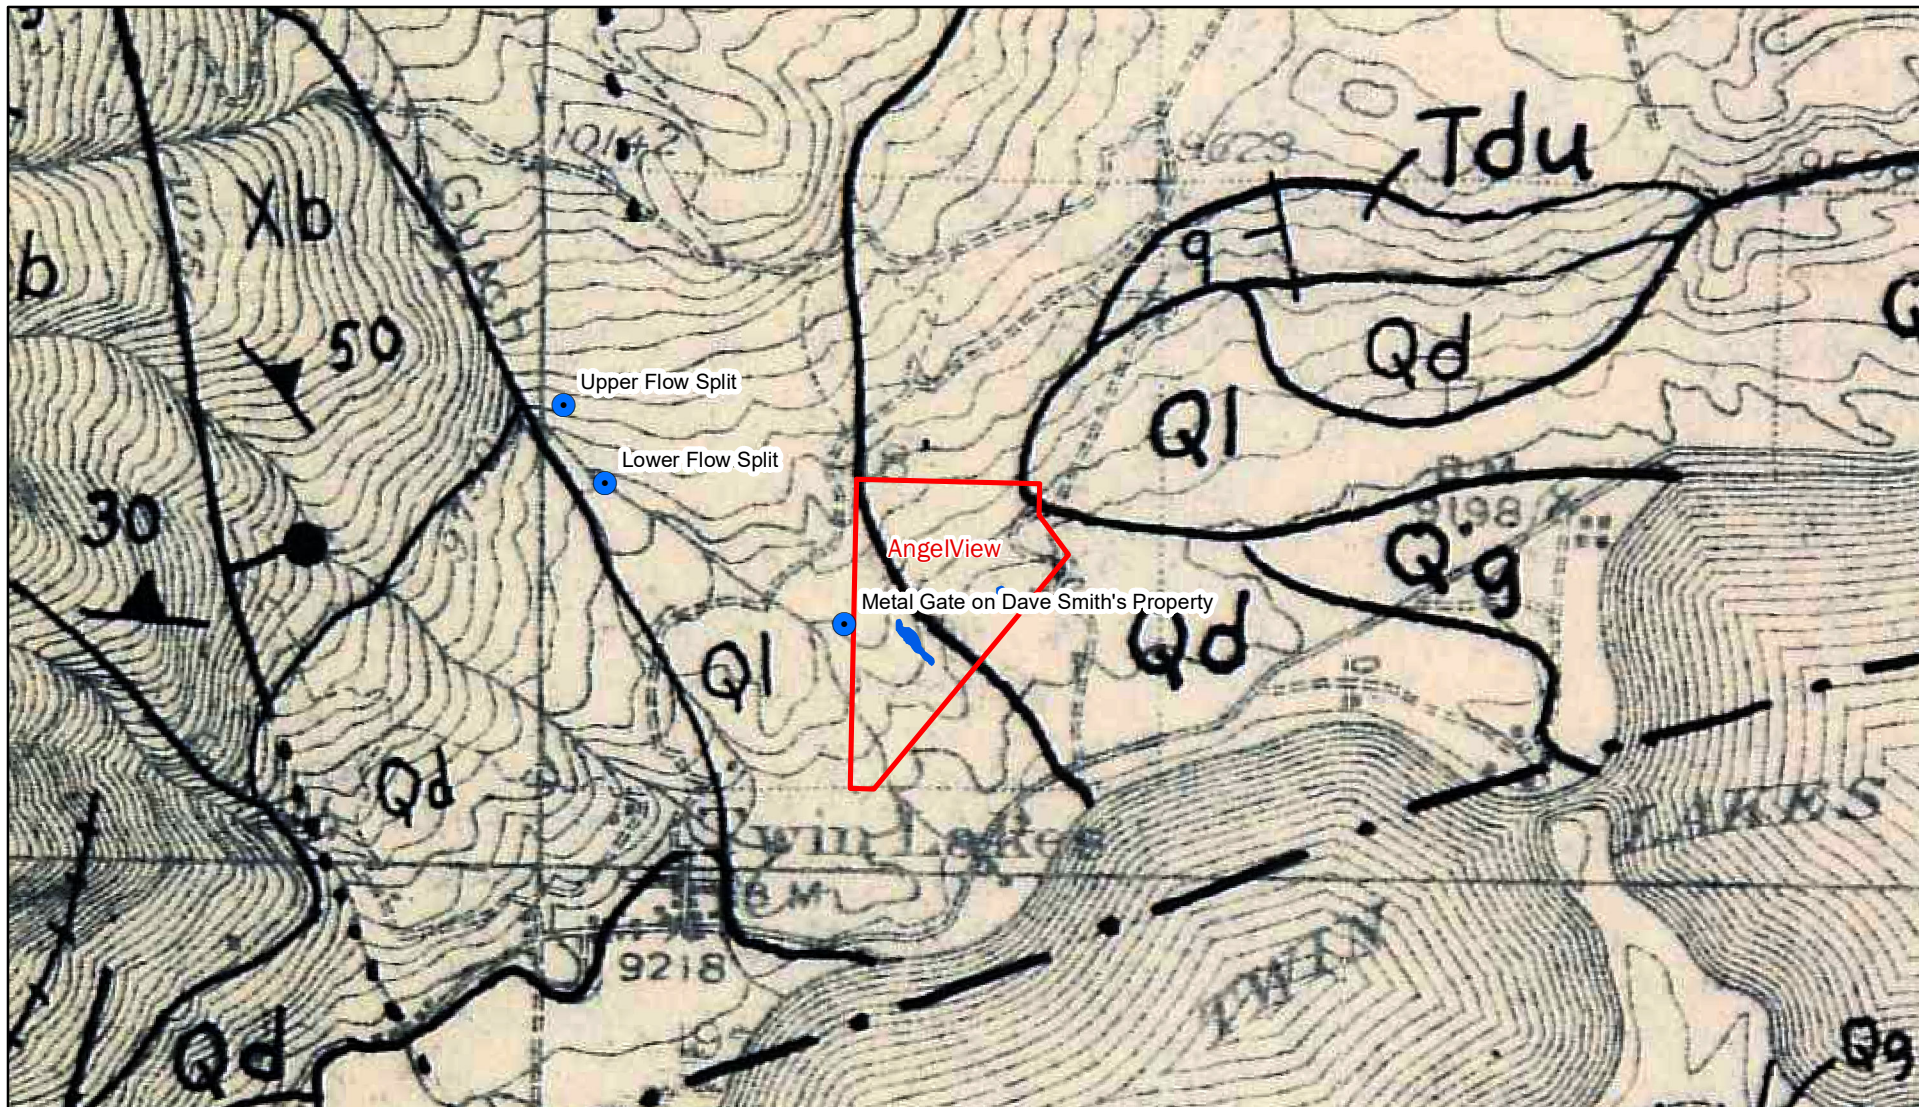
**Figure 2.6**  
**Angel View LLC**  
**U.S. Geological Survey**  
**Leadville Quadrangle Geologic Map**

The Kahn publication test site includes single well pumping test and double ring infiltrometer infiltration test results from deposits mapped as landslide deposits, which is the same geologic deposit (QI, which is identified in Figure 2.6 from our March 7, 2022 Disclosure) along Bartlett Gulch west of, and including, the southwest half of the AngelView Property. The hydraulic conductivity test results and associated travel times for the 2,380-foot distance from the Southern Eastern Channel and the Northern Eastern Channel split to Fen A are presented in Table 2. As with Table 1, the travel times for unconsolidated deposits that are not cemented together, such as ferricrete, are well within the 8-month period between when surface water to the Eastern Channel was terminated to the site visit conducted on May 6, 2022.

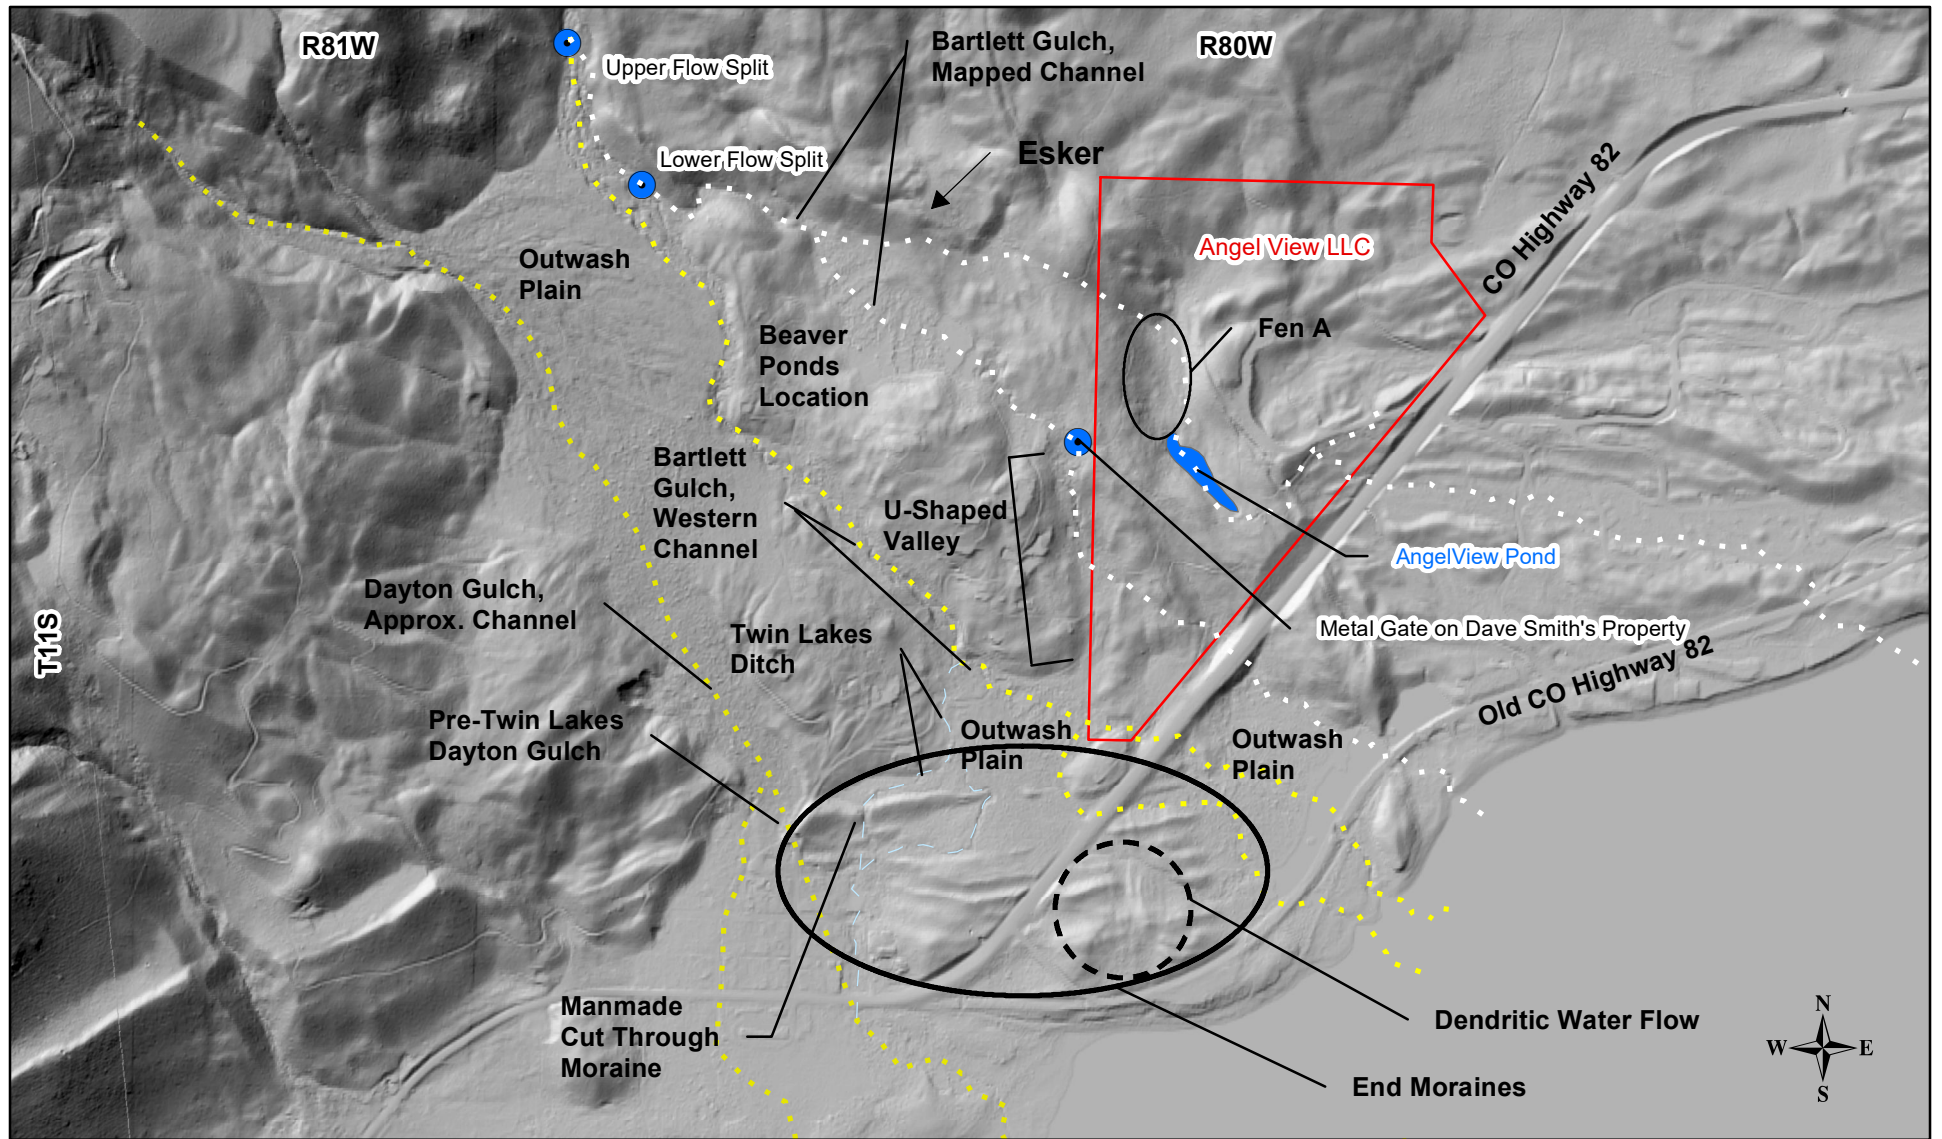
**Figure 2.7**  
**Angel View LLC**  
**North Arkansas River Valley LiDAR**

Figure 2.7 from our March 7, 2022 Expert Report (attached) illustrates our opinion regarding the mapped Easterly Channel. Between the Lower Flow Split and the Beaver Ponds Location identified on Figure 2.7, the Eastern Channel splits into a northern subsurface channel (Northern Eastern Channel) that leads to Fen A and AngelView Pond, and a southern channel (Southern Eastern Channel) that travels through the Beaver Ponds Location and the U-Shaped Valley before reaching Twin Lakes. The Southern Eastern Channel to our knowledge has always had surface water flow when flow to the Eastern Channel has not been terminated. It is our opinion that surface water flow to the Northern Eastern Channel becomes groundwater flow where the Southern Eastern Channel and the Northern Eastern Channel split. This opinion is based on the bedrock trough that is evident below the Esker that is labeled in Figure 2.7, along with the small surface water drainage basin described in Section 3, which in our opinion is not a large enough surface water drainage basin to provide sufficient continuous water to Fen A.

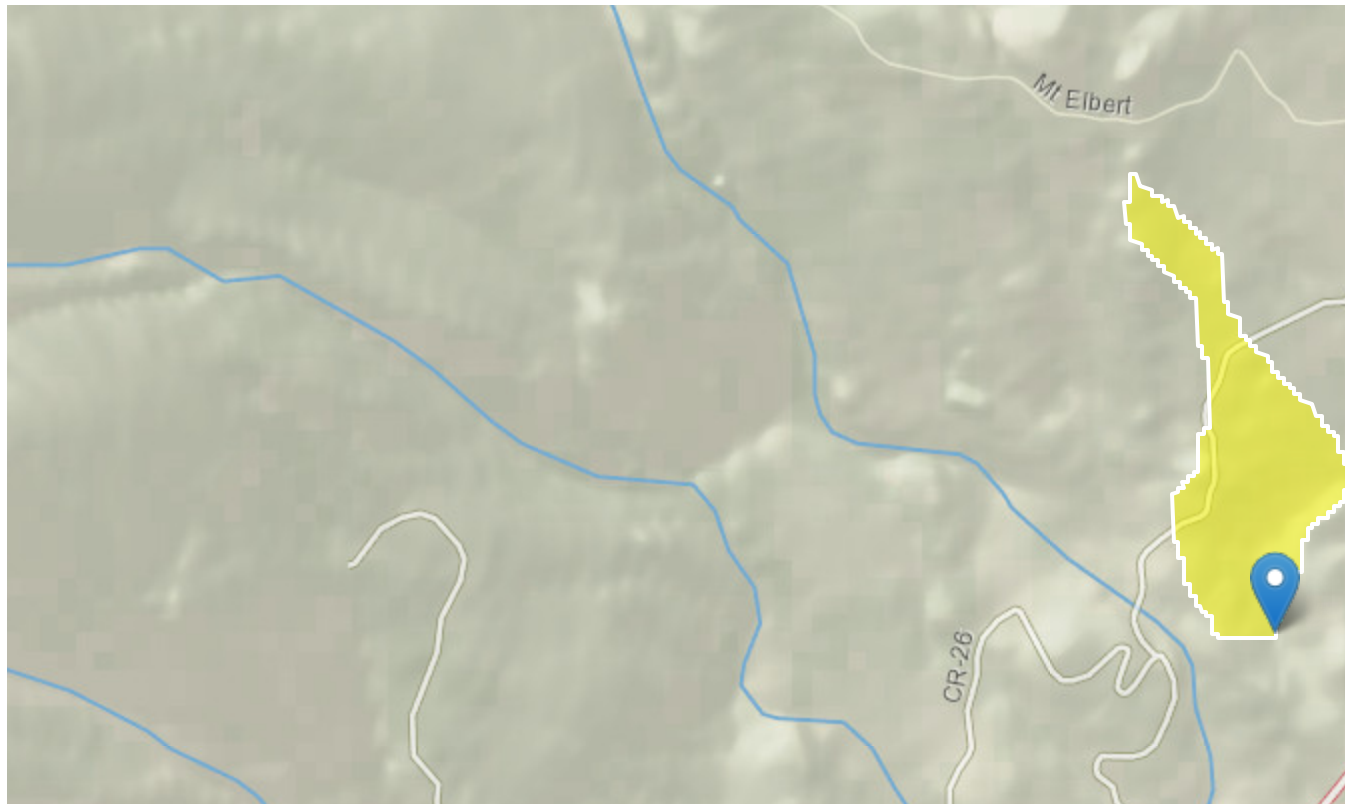
StreamStats was used to generate monthly and annual average runoff to ascertain whether or not precipitation would be sufficient to sustain the development of Fen A. The StreamStats report (attached as Appendix A) calculated a drainage area of 0.0541 square miles and estimated an average annual runoff flow rate of 0.0274 cfs using an average annual precipitation of 12.27 inches. The stated precipitation would generate a total of 35.40 acre-feet on an annual basis. The average annual volume of runoff calculated from the average annual runoff flow rate is 19.85 acre-feet, which leaves 15.55 acre-feet for use by native vegetation and deep percolation. Applying the SEO default native vegetation credit of 70% to the total precipitation volume of 35.40 acre-feet results in native vegetation consumption of 24.78 acre-feet, which exceeds the 15.55 acre-feet available. While the consumptive use of native vegetation is likely lower than the SEO default value of 70%, it is our opinion that this analysis demonstrates that on an average annual basis the drainage basin above the fen cannot generate sufficient surface water and groundwater to sustain Fen A.
